ANNUAL REPORT FOR 2009

**Unnamed Tributary to Little Jacob
Swamp Mitigation Site
Robeson County
TIP No. R-0513WM**

Prepared By:
Natural Environment Unit & Roadside Environmental Unit
North Carolina Department of Transportation
December 2009

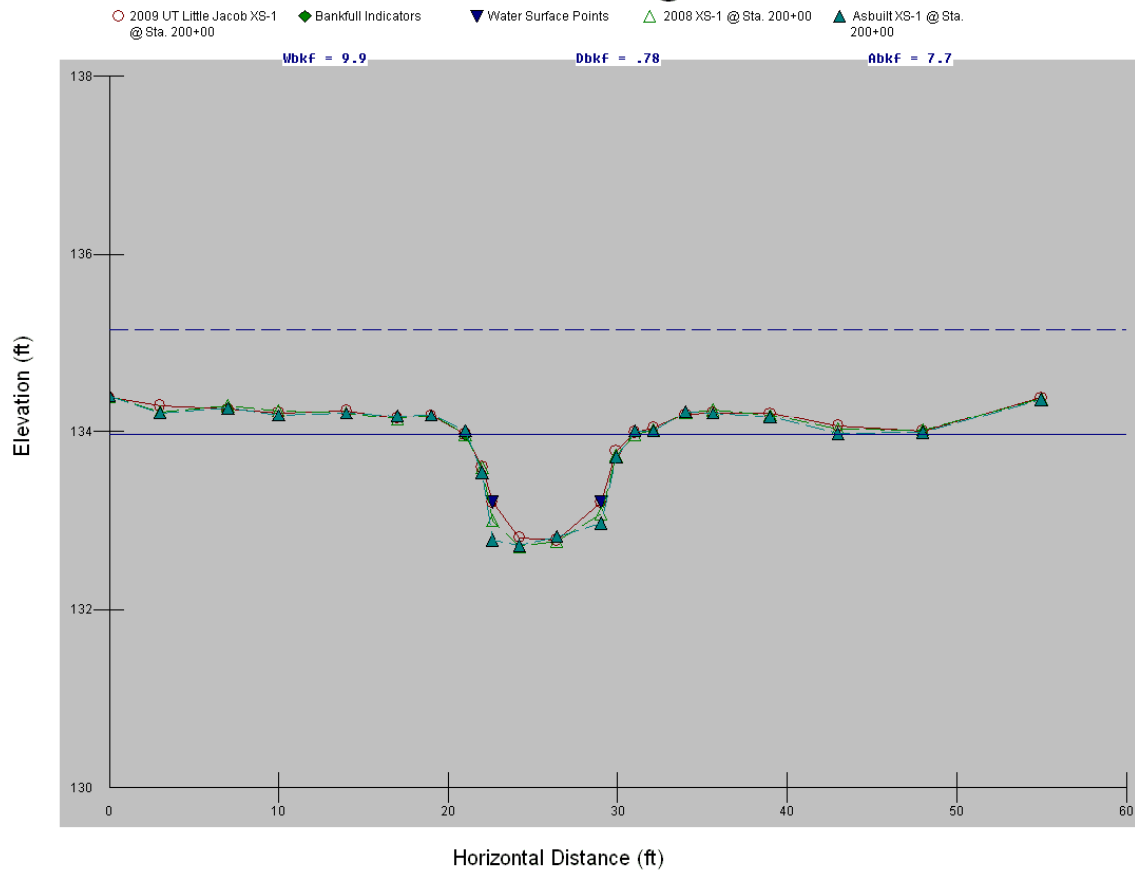
2009 UT Little Jacob XS-1 @ Sta. 200+00

Cross-Section #1 (Riffle) Abbreviated Morphological Summary					
	2008	2009	2010	2011	2012
Bankfull Width (ft)	10.0	10.04			
Bankfull Mean Depth (ft)	0.84	0.78			
Width/Depth Ratio	11.9	12.87			
Bankfull Cross Sectional Area (ft ²)	8.44	7.80			
Maximum Bankfull Depth (ft)	1.26	1.20			
Width of the Floodprone Area (ft)	55	55			
Entrenchment Ratio	5.5	5.48

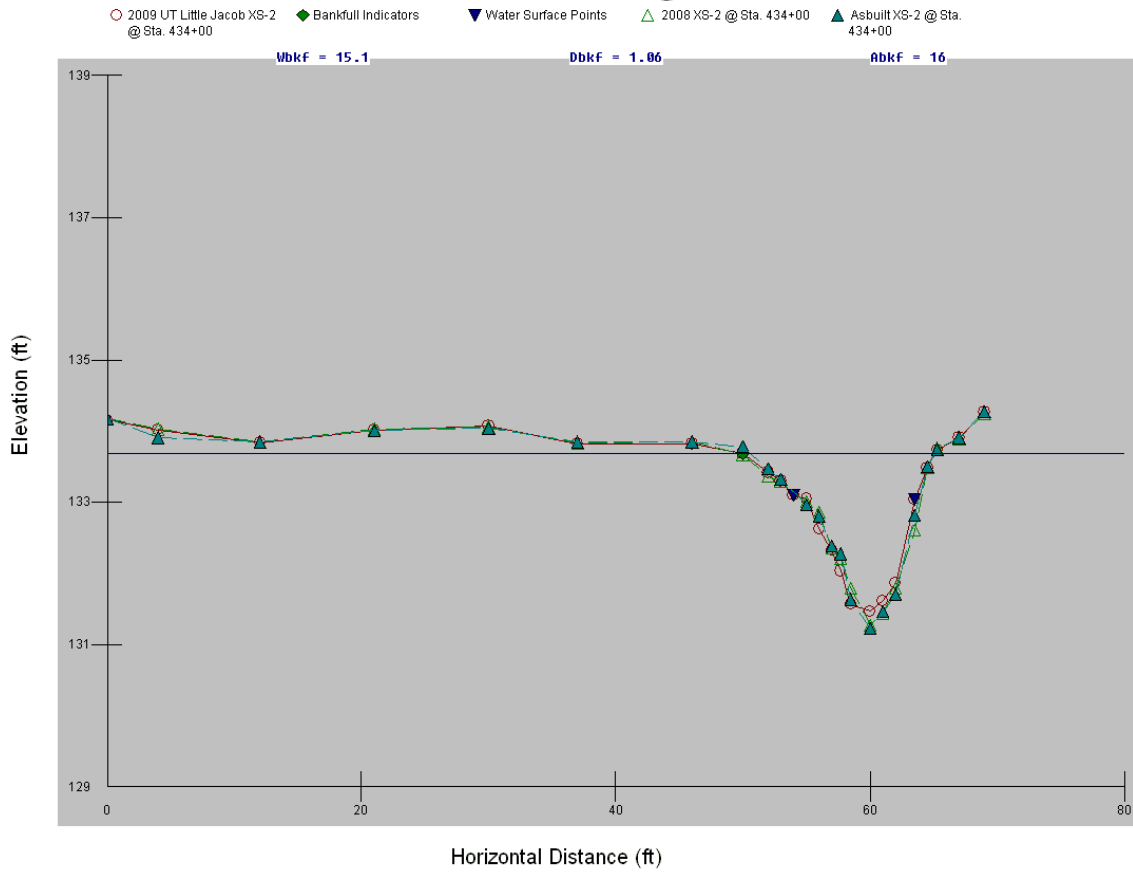
2009 UT Little Jacob XS-2 @ Sta. 434+00

Cross-Section #2 (Pool) Abbreviated Morphological Summary*					
	2008	2009	2010	2011	2012
Bankfull Cross Sectional Area (ft ²)	16.17	16.01			
Maximum Bankfull Depth (ft)	2.39	2.22			
Bankfull Mean Depth (ft)	1.08	1.06			
Bankfull Width (ft)	15.03	15.14

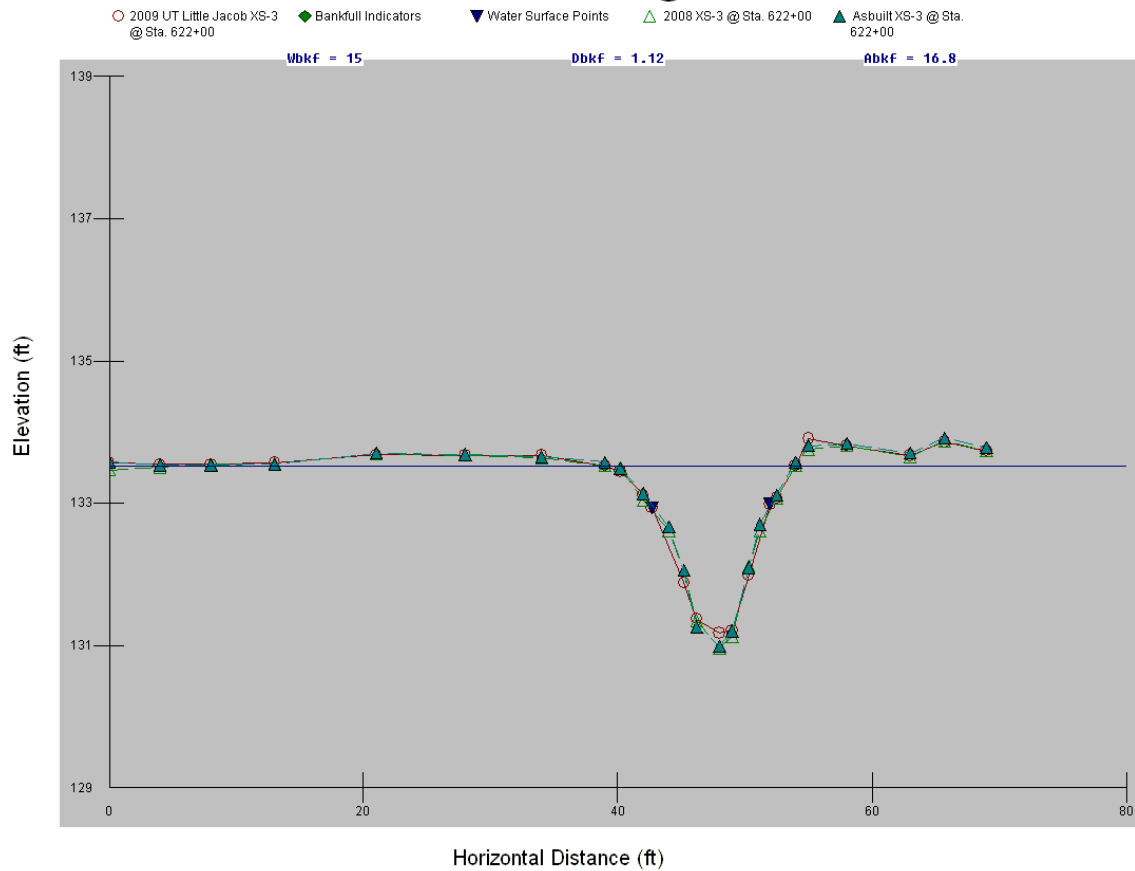
2009 UT Little Jacob XS-3 @ Sta. 622+00

Cross-Section #3 (Pool) Abbreviated Morphological Summary*					
	2008	2009	2010	2011	2012
Bankfull Cross Sectional Area (ft ²)	16.78	16.76			
Maximum Bankfull Depth (ft)	2.56	2.35			
Bankfull Mean Depth (ft)	0.8	1.12			
Bankfull Width (ft)	21.0	15

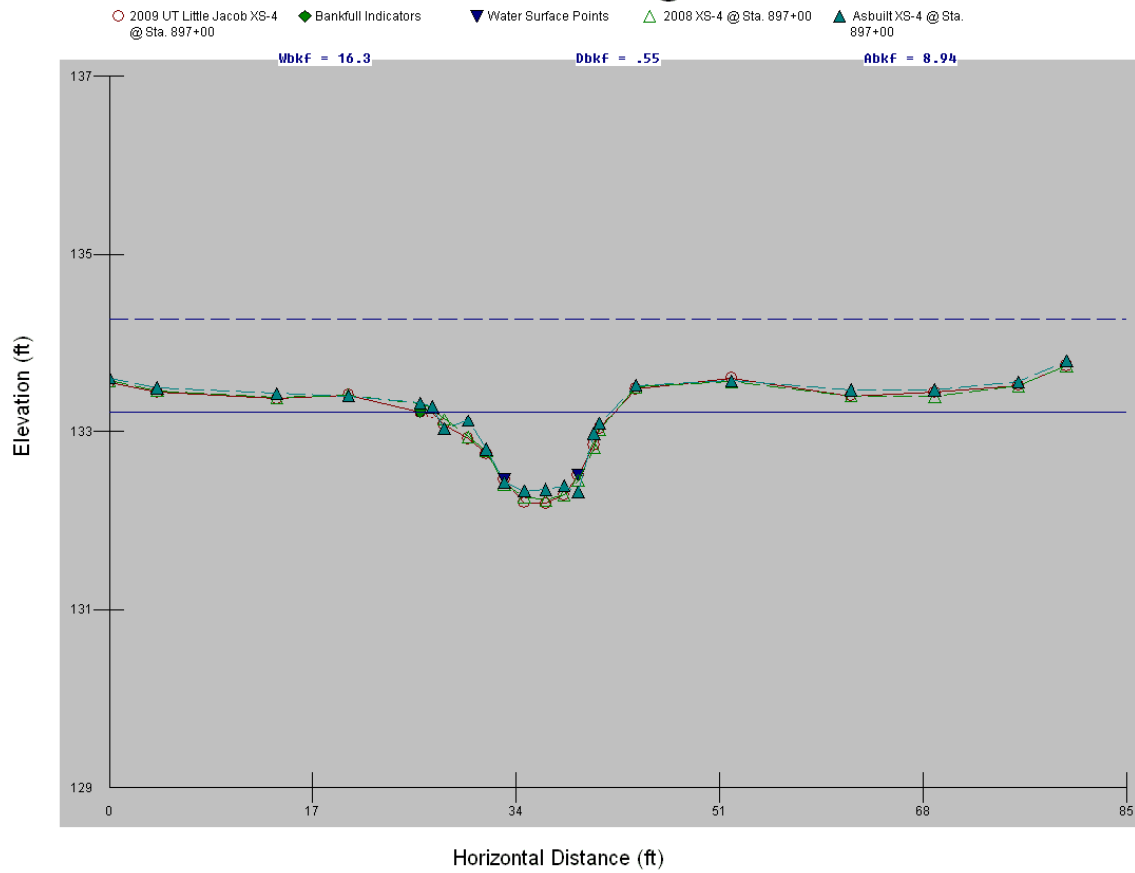
2009 UT Little Jacob XS-4 @ Sta. 897+00

Cross-Section #4 (Riffle) Abbreviated Morphological Summary					
	2008	2009	2010	2011	2012
Bankfull Width (ft)	16.84	16.27			
Bankfull Mean Depth (ft)	0.60	0.55			
Width/Depth Ratio	28.07	29.58			
Bankfull Cross Sectional Area (ft ²)	10.16	8.94			
Maximum Bankfull Depth (ft)	1.09	1.04			
Width of the Floodprone Area (ft)	80	80			
Entrenchment Ratio	4.75	4.92

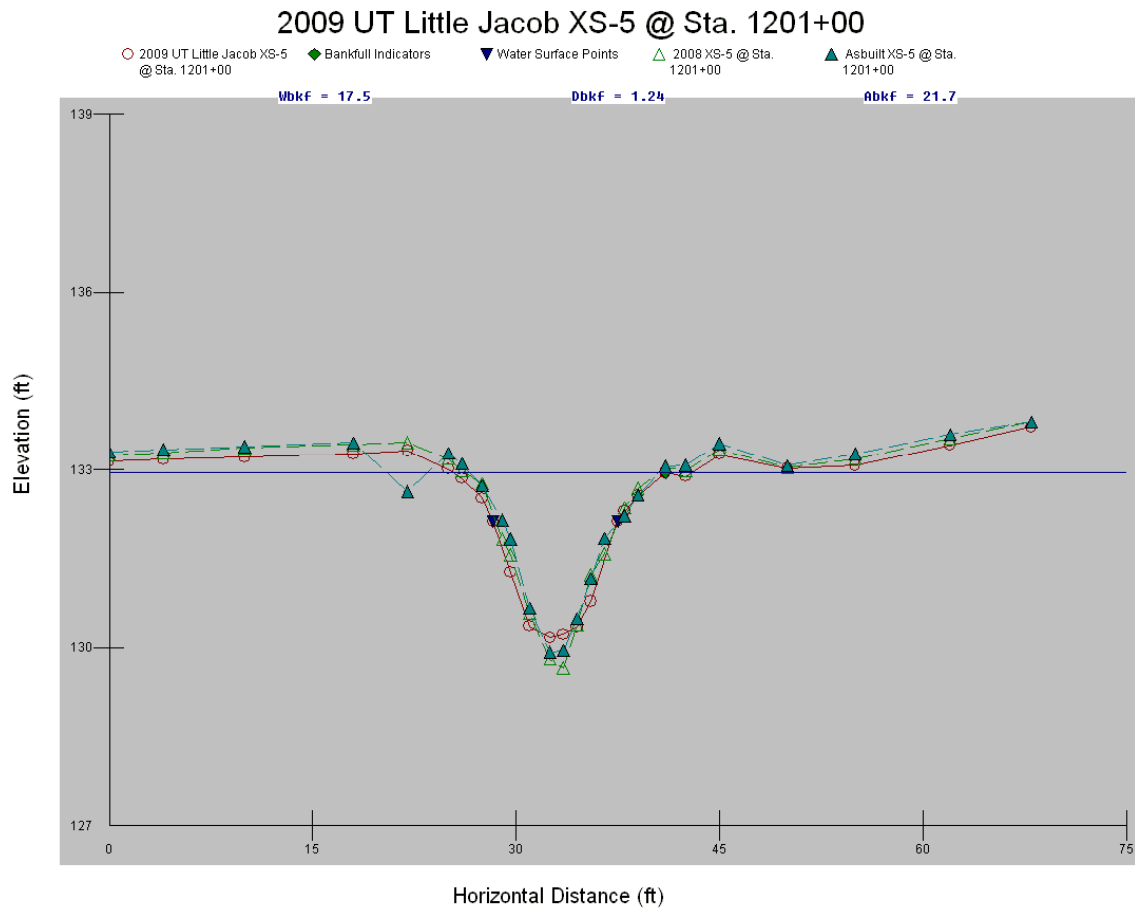
Cross-Section #5 (Pool) Abbreviated Morphological Summary*					
	2008	2009	2010	2011	2012
Bankfull Cross Sectional Area (ft ²)	22.13	20.88			
Maximum Bankfull Depth (ft)	3.39	2.73			
Bankfull Mean Depth (ft)	1.24	1.42			
Bankfull Width (ft)	8.91	14.74

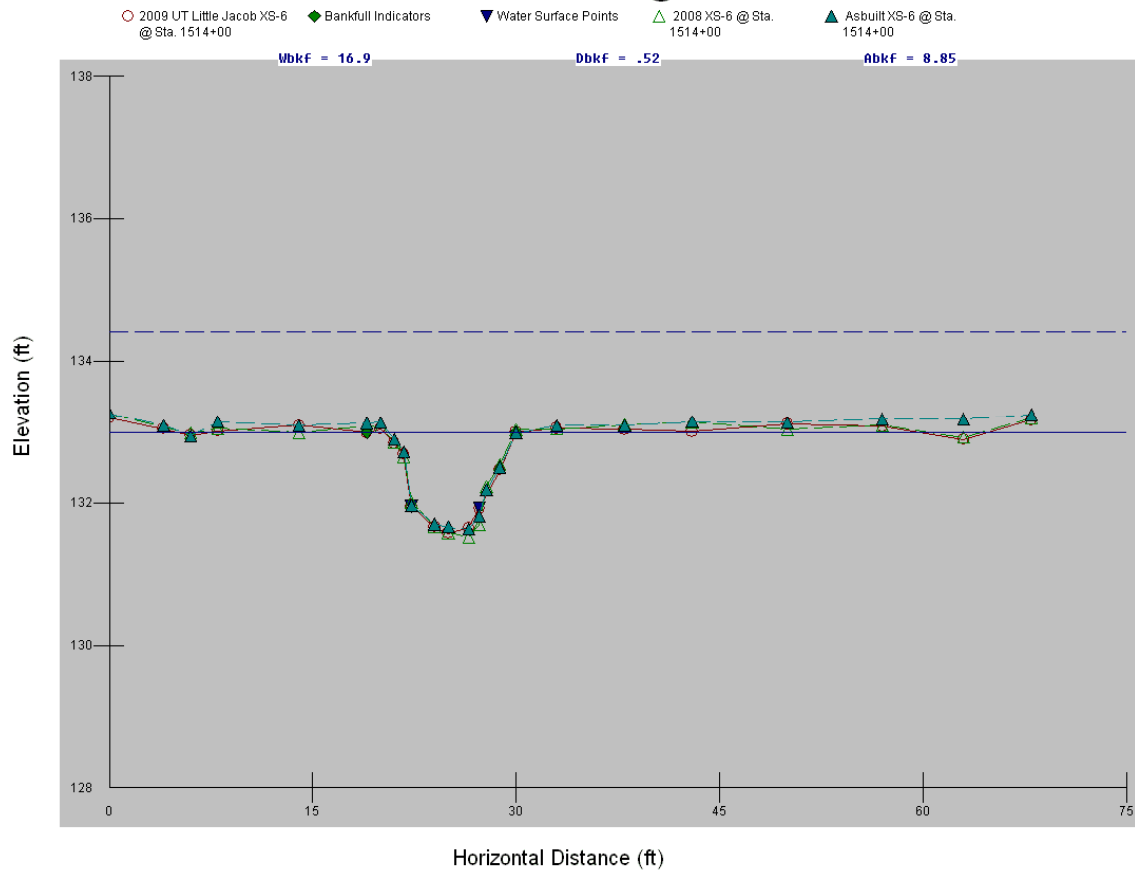
2009 UT Little Jacob XS-6 @ Sta. 1514+00

Cross-Section #6 (Riffle) Abbreviated Morphological Summary

2008	2009	2010	2011	2012
Bankfull Width (ft)	9.8	9.75			
Bankfull Mean Depth (ft)	0.91	0.88			
Width/Depth Ratio	10.77	11.08			
Bankfull Cross Sectional Area (ft ²)	8.94	8.56			
Maximum Bankfull Depth (ft)	1.51	1.42			
Width of the Floodprone Area (ft)	68	68			
Entrenchment Ratio	6.94	6.97

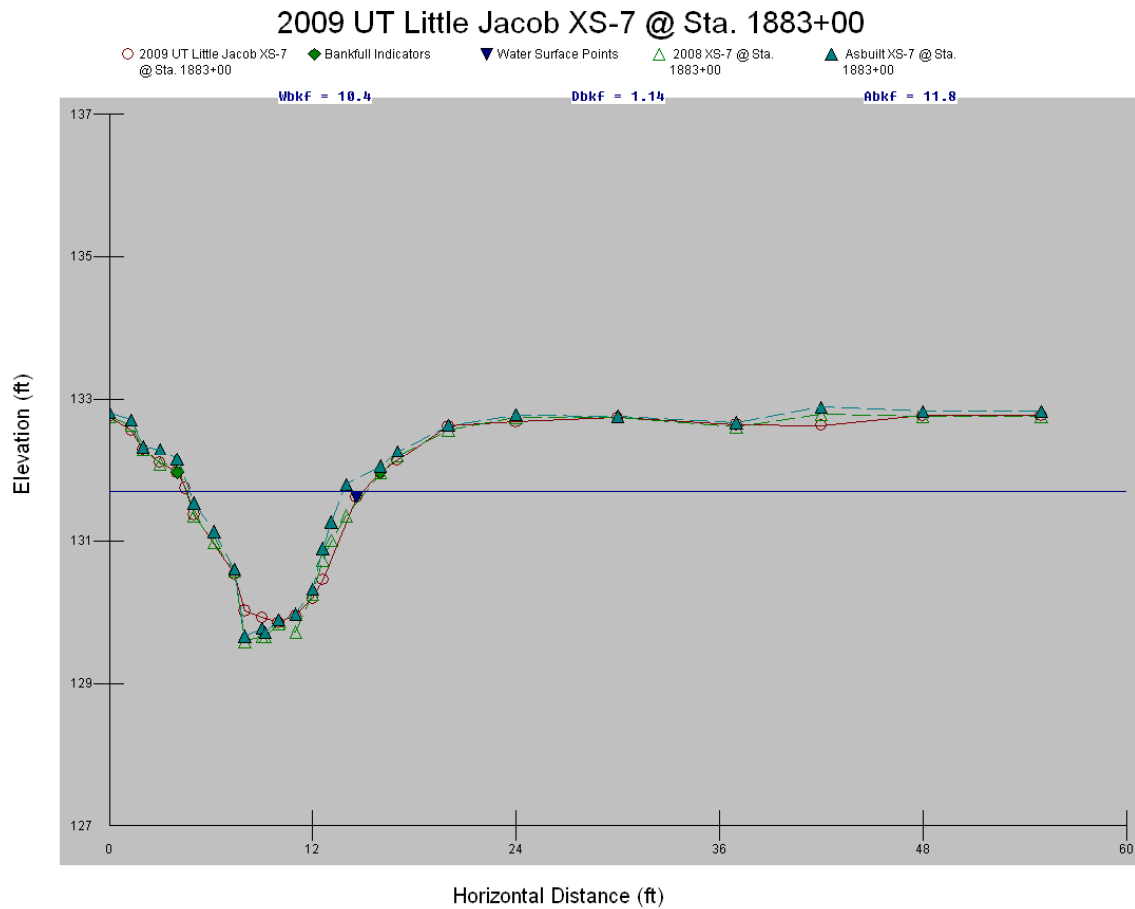
Cross-Section #7 (Pool) Abbreviated Morphological Summary*					
	2008	2009	2010	2011	2012
Bankfull Cross Sectional Area (ft ²)	15.14	14.80			
Maximum Bankfull Depth (ft)	2.37	2.11			
Bankfull Mean Depth (ft)	0.80	1.23			
Bankfull Width (ft)	11.85	12.0

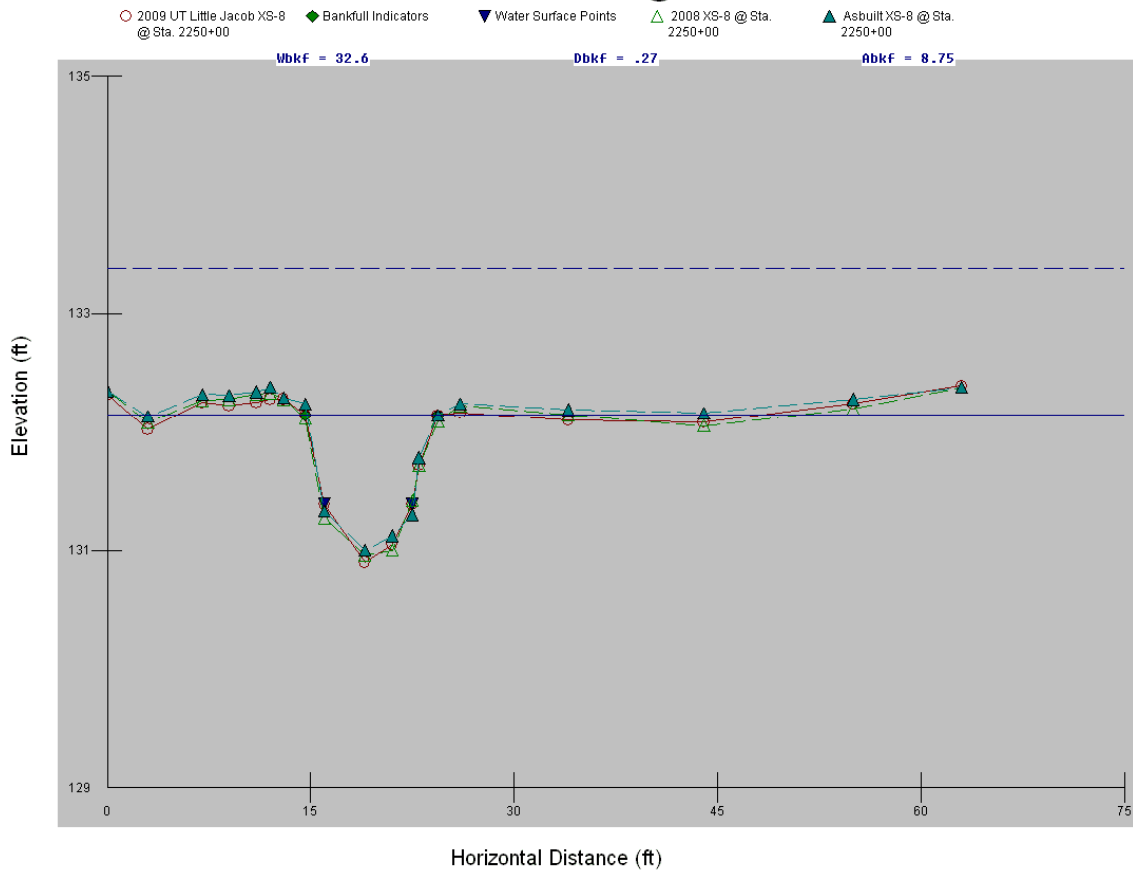
2009 UT Little Jacob XS-8 @ Sta. 2250+00

Cross-Section #8 (Riffle) Abbreviated Morphological Summary

2008	2009	2010	2011	2012
Bankfull Width (ft)	9.77	9.8			
Bankfull Mean Depth (ft)	0.78	0.80			
Width/Depth Ratio	12.53	12.25			
Bankfull Cross Sectional Area (ft ²)	7.64	7.82			
Maximum Bankfull Depth (ft)	1.14	1.24			
Width of the Floodprone Area (ft)	63	63			
Entrenchment Ratio	6.45	6.43

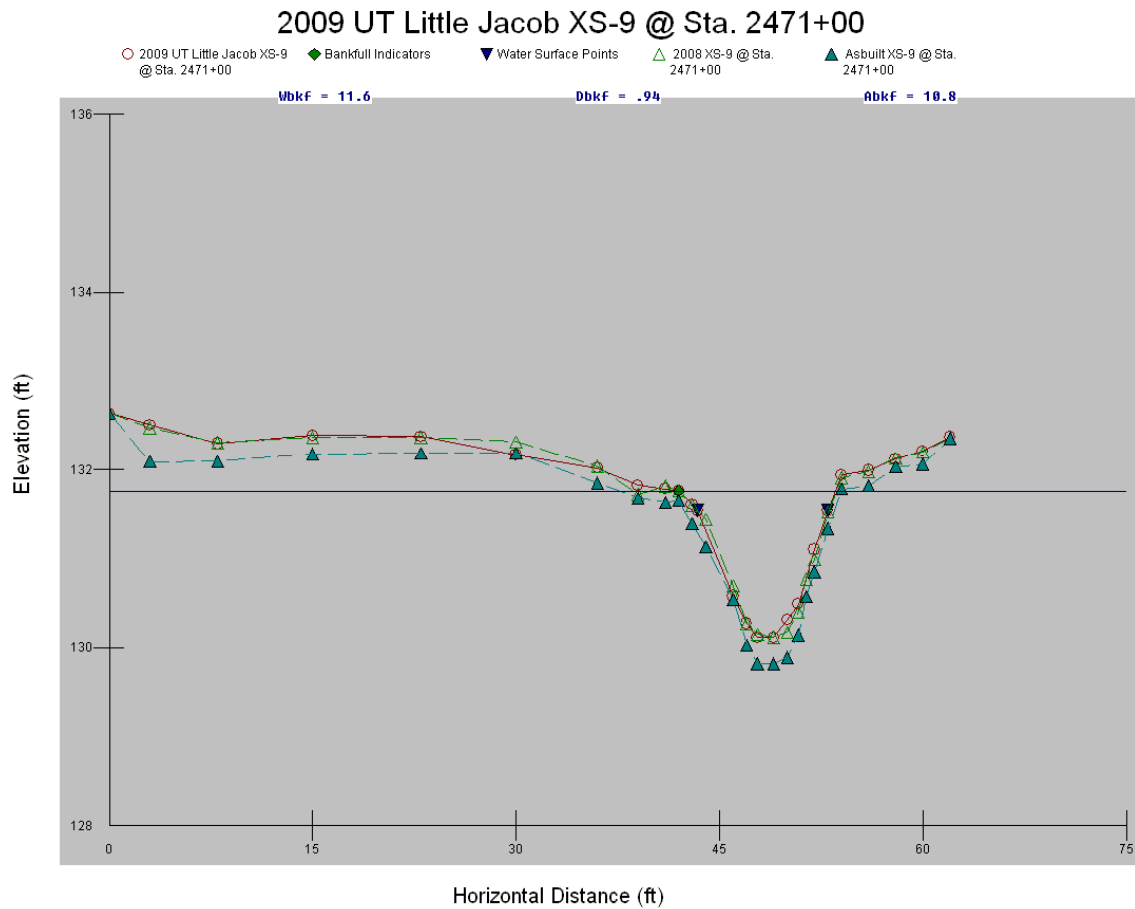
Cross-Section #9 (Pool) Abbreviated Morphological Summary*					
	2008	2009	2010	2011	2012
Bankfull Cross Sectional Area (ft ²)	10.8	10.84			
Maximum Bankfull Depth (ft)	1.64	1.65			
Bankfull Mean Depth (ft)	0.93	0.94			
Bankfull Width (ft)	11.56	11.55

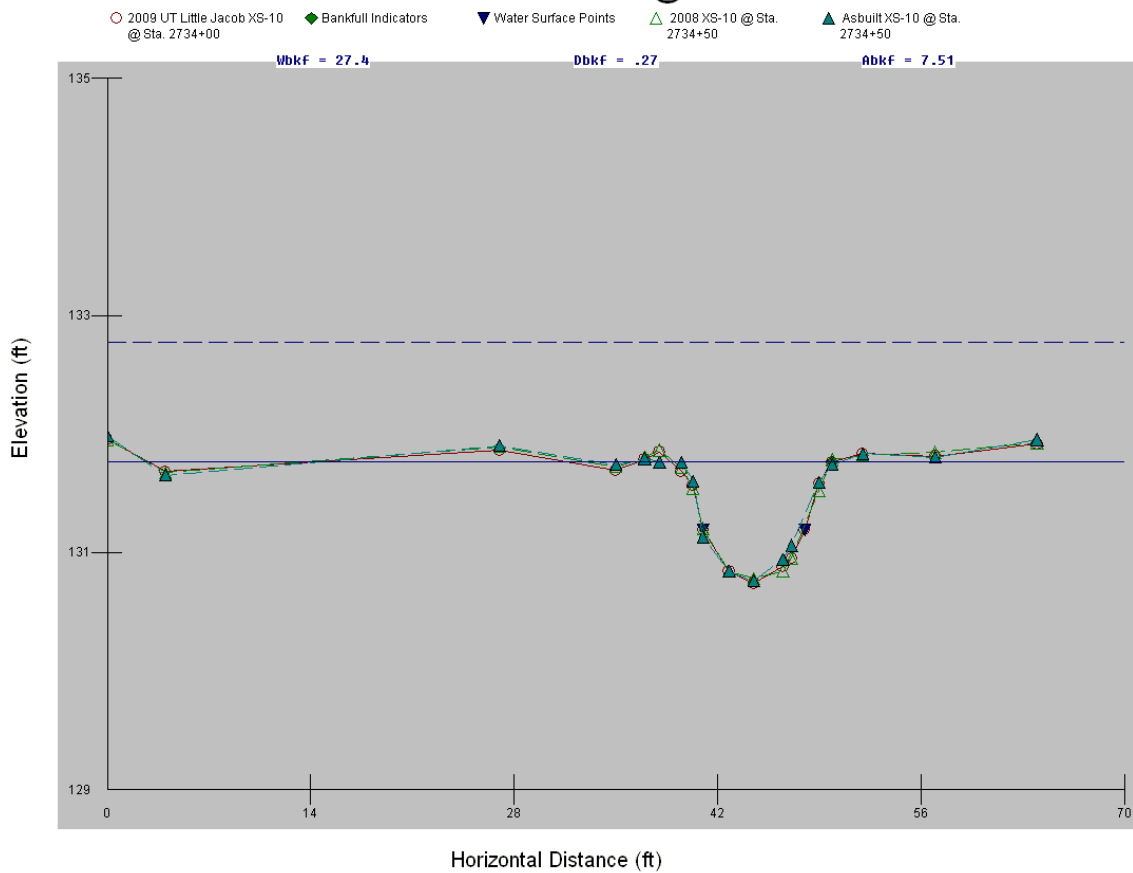
2009 UT Little Jacob XS-10 @ Sta. 2734+50

Cross-Section #10 (Riffle) Abbreviated Morphological Summary					
	2008	2009	2010	2011	2012
Bankfull Width (ft)	11.1	11.1			
Bankfull Mean Depth (ft)	0.64	0.62			
Width/Depth Ratio	17.34	17.9			
Bankfull Cross Sectional Area (ft ²)	7.08	6.89			
Maximum Bankfull Depth (ft)	1.0	1.02			
Width of the Floodprone Area (ft)	64	64			
Entrenchment Ratio	5.77	5.77

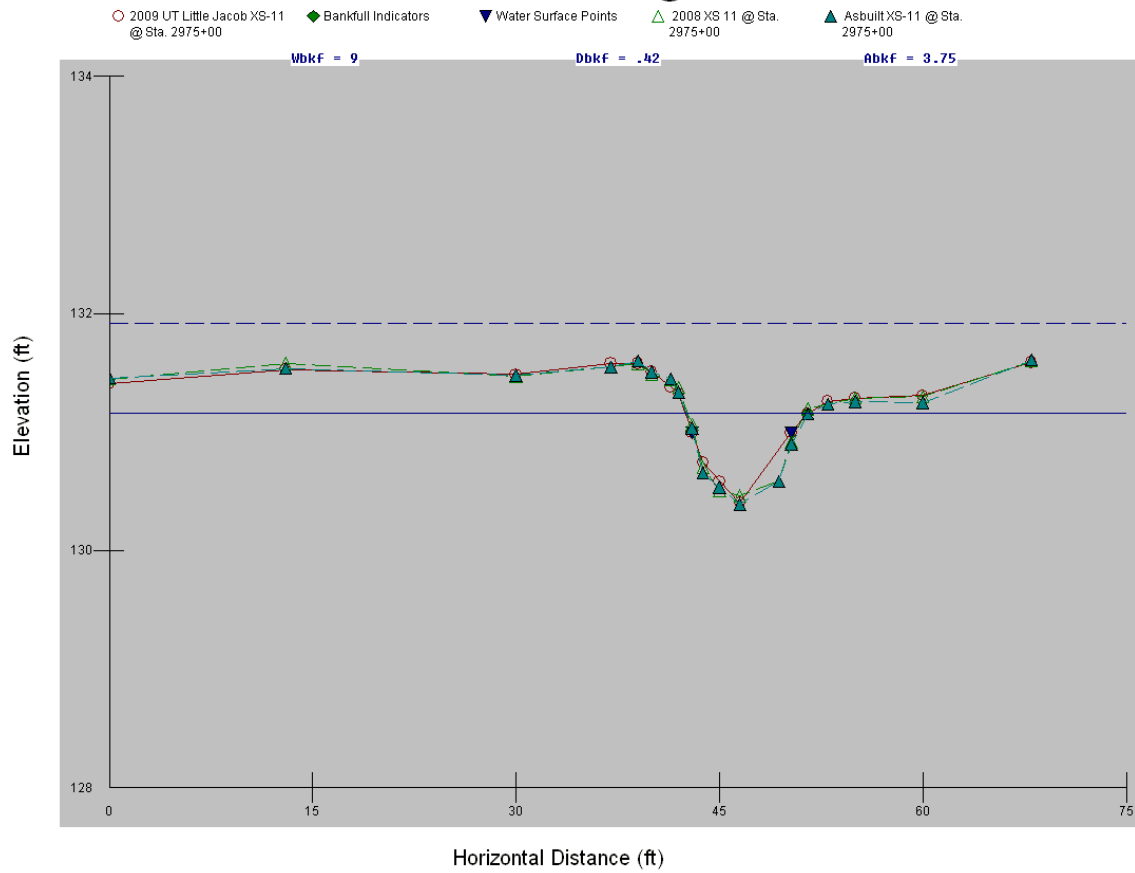
2009 UT Little Jacob XS-11 @ Sta. 2975+00

Cross-Section #11 (Riffle) Abbreviated Morphological Summary					
	2008	2009	2010	2011	2012
Bankfull Width (ft)	8.94	9.0			
Bankfull Mean Depth (ft)	0.52	0.42			
Width/Depth Ratio	17.19	21.43			
Bankfull Cross Sectional Area (ft ²)	4.64	3.75			
Maximum Bankfull Depth (ft)	0.74	0.76			
Width of the Floodprone Area (ft)	68	68			
Entrenchment Ratio	7.61	7.56
